Technical Report ARFSD-TR-03002

PREDICTING THE CAUSE OF FAILURE IN 120-mm MORTAR FINS

July 2003

U.S. ARMY ARMAMENT RESEARCH, DEVELOPMENT AND
ENGINEERING CENTER

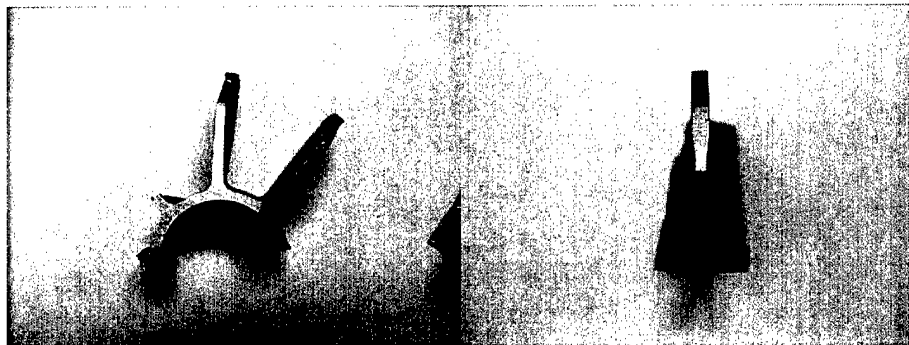
Figure 2
Two broken fin parts, flat fin plus cylindrical part

cause of failure between fins (fig. 2) is a defect at a high-hoop stress region that results in fracture failure. The fracture failure occurs from an internal pressure in the fin cylinder. Yielding is probably not visible.

crack size was estimated at 0.23 mm (0.009 in.). As shown in figure 2, several of the broken fins had failure modes consistent with fracture failure. The failure surface was rough and without discernable yielding of the fins or fin cylinder.

The analysis indicated that a fracture could occur with large internal pressures at critical defects. The smallest crack size was predicted with longitudinal cracks on the inside of the fin cylinder. This type of defect is consistent with scoring due to assembly at the press fit. Evidence of scoring was found in some broken parts, but it was not clear that scoring had caused a specific failure. However, the broken parts shown in figure 2 are consistent with the high stress regions in figure 6b.

Six-sigma techniques are being used to assess the manufacturing and assembly process. The goal is to reduce the size and number of scoring defects on the inside of the fin cylinder.

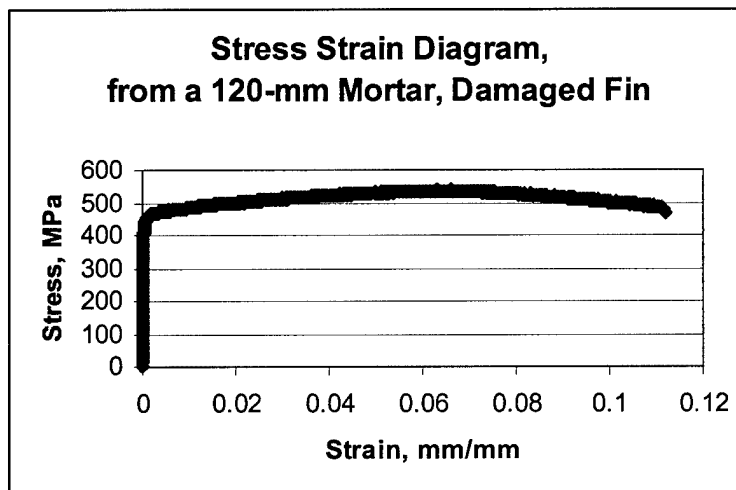
Both parts of the tail assembly were extruded from aluminum. Young's Modulus was 73,023 MPa, Poisson's ratio was 0.3, and the mass density was 2.3-gm/cm³. The perforated section was modeled as a linear-elastic material. The fin section was modeled as an elastic-plastic material. Points from a tensile test of a fin were used to model the fin part (fig. 5). The engineering yield and ultimate strength were 464 and 502 MPa. ABAQUS uses the true stress and strain, 466 MPa for yield and 538 MPa for ultimate tensile strength.

Figure 5
Stress/strain diagram from damaged fin

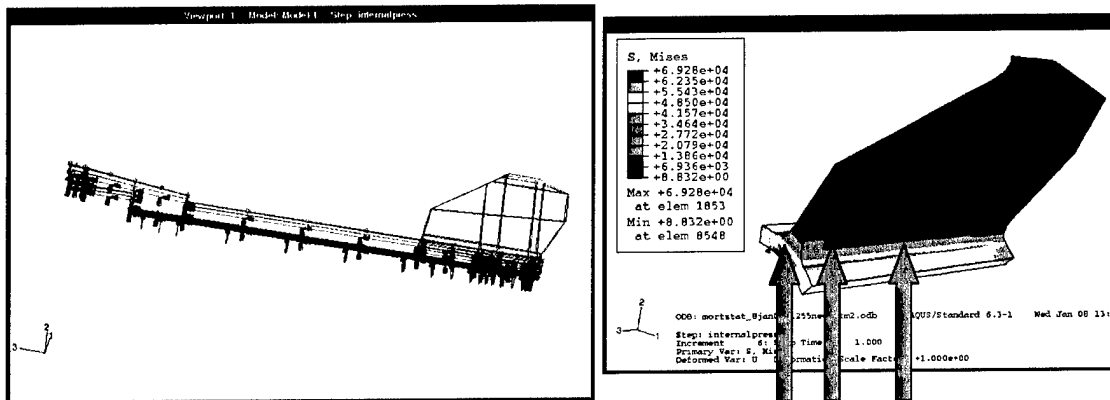
The internal pressure of 98 MPa, load case 2 from table 1, resulted in three, high-stress regions (fig. 6b). There are high von Mises stresses directly under the fin and at the inner diameter of the cylinder, at the fin fillet on the outside of the fin cylinder, and midway between the fins on the inside of the fin tube. Yielding was predicted directly under the fin on the inside of the cylinder. The plastic region did not go through the thickness of the cylinder and the von Mises stress was below the ultimate tensile strength of the aluminum.

Figure 6
Internal pressure on fin assembly, 98 MPa

Critical crack sizes were predicted for the three high-stress regions shown in figure 6b. The smallest critical cracks resulted from the longitudinal cracks opened by the hoop stresses. For load, the 98-MPa internal pressure, the smallest critical flaw on the inside of the cylinder, was estimated at 0.18 mm (0.007 in.). Along the outside of the cylinder, the smallest critical

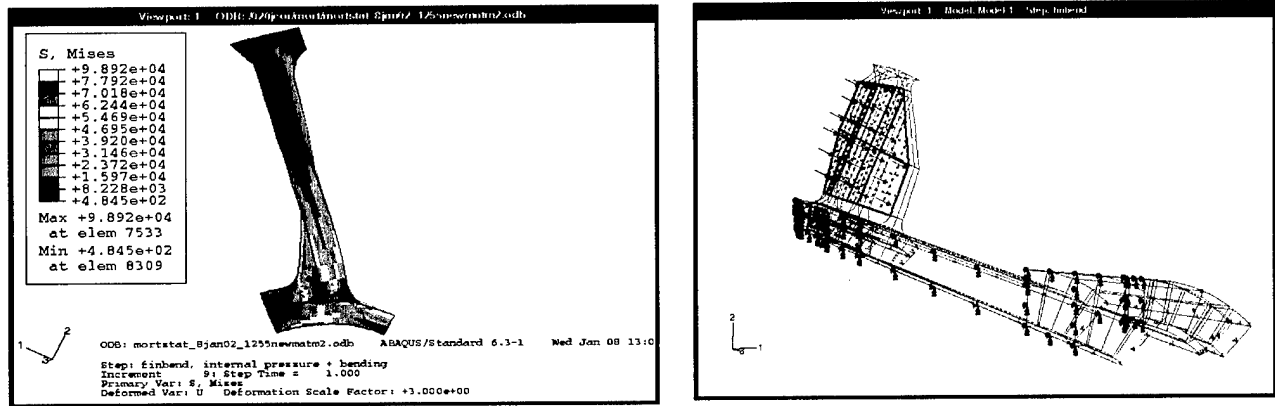
Figure 7a shows load case 4, an unequal pressure on one side of the fin. A pressure of 1.4 MPa resulted in yielding of the fin near the root. A pressure of 2.1 MPa resulted in von Mises stresses exceeding the ultimate tensile strength of the aluminum (figure 7b in units psi). At the 2.1-MPa pressure, the plastic zone extended through the fin thickness, indicating probable tearing of the fin at this location. Numerous examples of broken and twisted fins were consistent with the deformation and stresses shown in figure 7b.

Figure 7
Load case 4: pressure on one side of fin
